Appendix E2a.ii (2) – Restoration Plans and TMDLs (Restoration Inspections)

STORM WATER MANAGEMENT INSPECTION REPORT

Project: Anita C. Leight Estuary Center Micro-bioretenion 1
Site Address: 618 Otter Point Rd, Abingdon, MD 21009

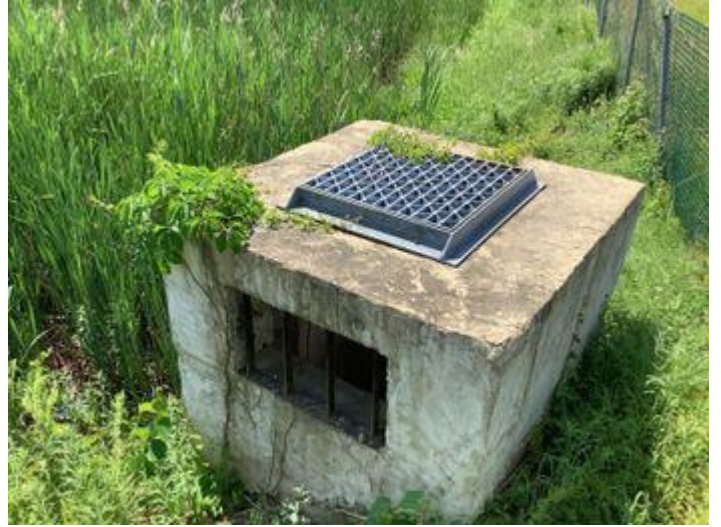
Photo 6

Description
Riser

Comments/Corrections:
Realign the top of the control structure.
Remove leaf debris from median.
Loosen the surface of mulch.

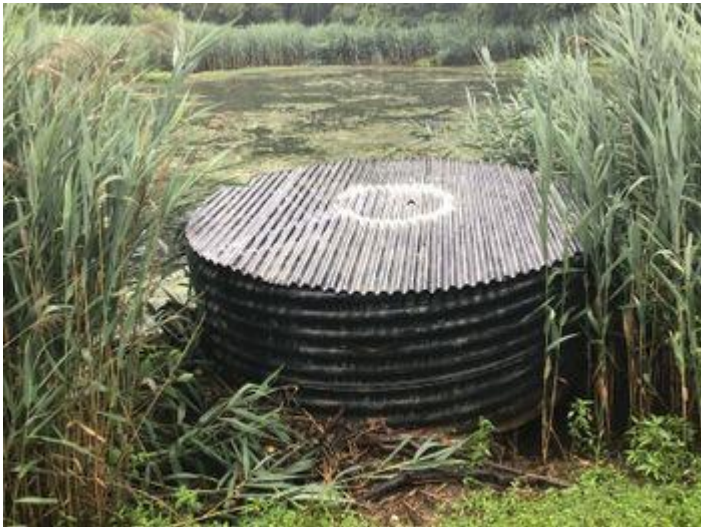
Photo 3

There is debris and vegetation around the riser.
There is vegetation in the emergency spillway.
The stormdrain outfall is overgrown.
The principal spillway outfall pipe is damaged.

Description
Riser

Remove the debris and vegetation within 25 feet of the riser.
Remove the vegetation from the emergency spillway.
Remove the vegetation from the stormdrain outfall.
The principal spillway outfall pipe must be replaced.

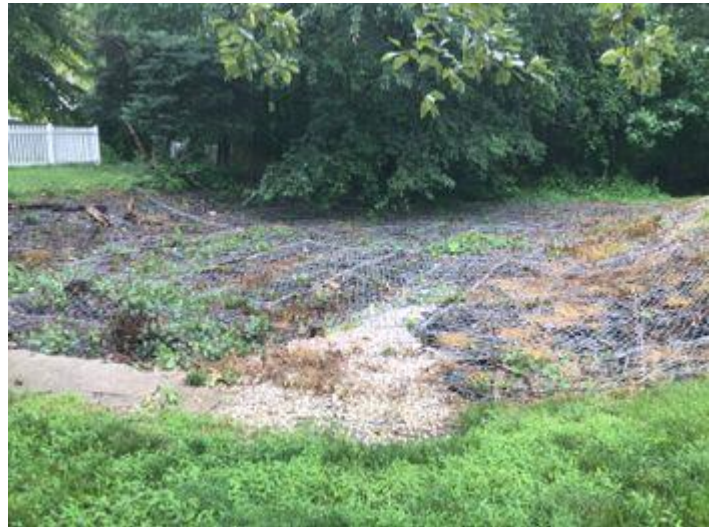
Photo 4

Description
Emergency spillway

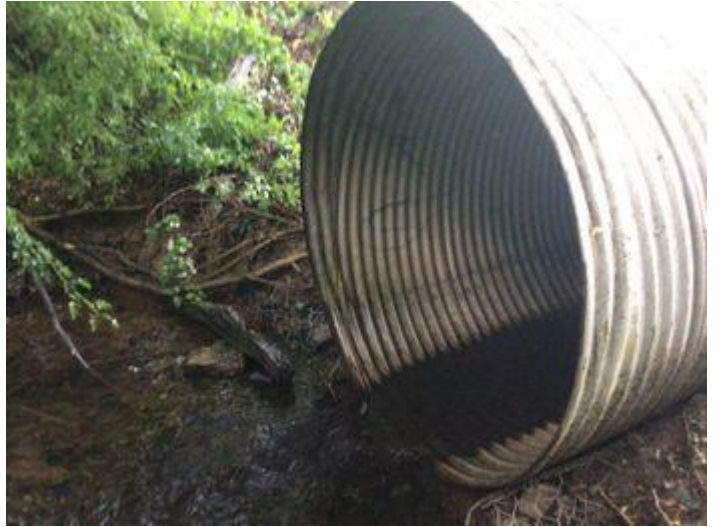
Photo 6

An inspection of the stormwater management facility was performed on June 22, 2021. It was determined during this inspection that the principal spillway pipe required replacement. The process, through DPW, is as follows:

Outfall pipe

The owner will hire a contractor to perform the pipe replacement. The geotech will monitor and record the compaction and materials during construction. The engineer or his representative will be required to inspect and maintain quality control throughout the project.
